(RCA)

**N70-27139**

## PREFACE

This report encompasses all the activities pertaining to Spare Storage Modules 028, 031, and 032 from October 15, 1969 to January 13, 1970. Test data obtained prior to October 15, 1969 are contained in Quarterly Progress Report No. 7, issued October 15, 1969 under NASA Contract NAS 5-10470.

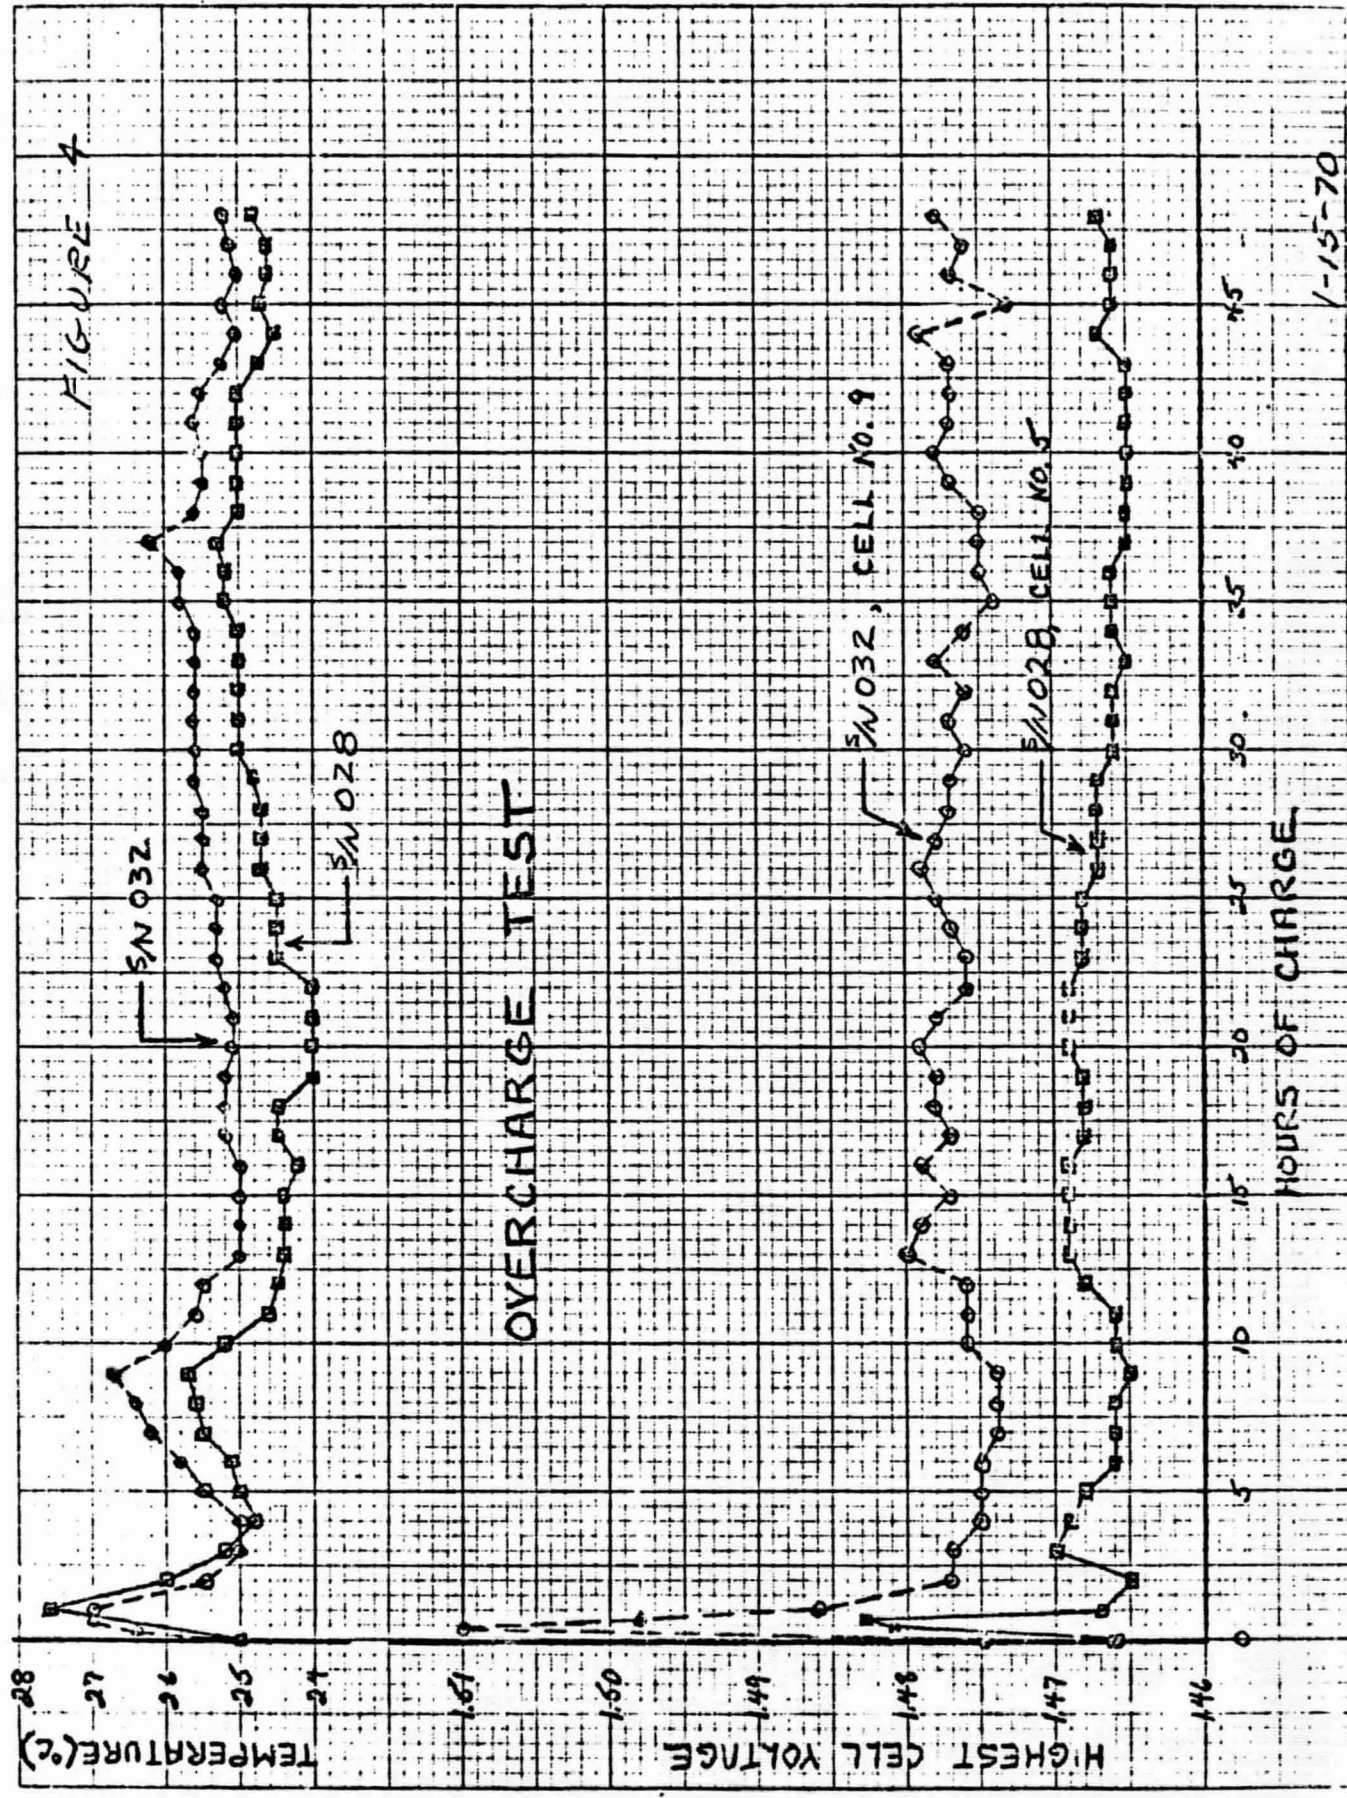
The temperature profile shown in Figure 1 was followed. Figures 2 and 3 are histograms of the cell voltages at different times throughout the overcharge test. At the end of the test the spread in cell voltage was small. Two of the highest cells were the replacement cells in both modules. These cells had not been subjected to a complete conditioning cycle prior to assembly in the modules. Figure 4 shows the temperature of each module throughout the test and the voltages of the two highest cells.
